NL INDUSTRIES/TARACORP SUPERFUND SITE GROUP
Leed Environmental, Inc.
Van Reed Office Plaza
2209 Quarry Drive, Suite C-35
Reading, PA 19609
Telephone: (610) 670-7310
Facsimile: (610) 670-7311

Re: NL Industries/Taracorp Superfund Site; Granite City, Illinois
First 2019 Semi-Annual Operation and Maintenance Inspection (May 2019)

Inspection Date: 5/20/2019

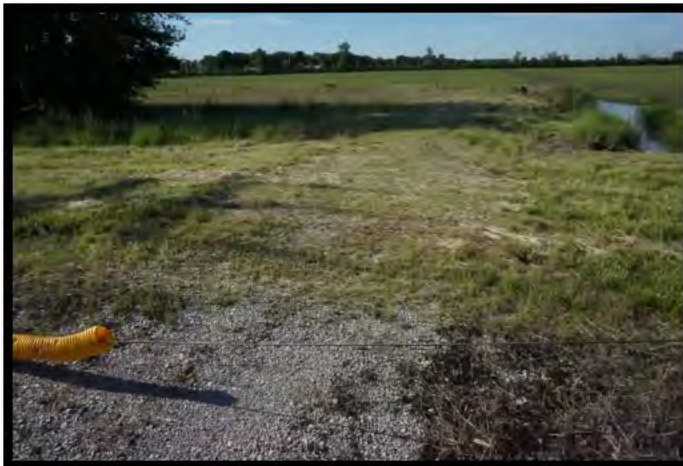
Photograph 3: Sand Road property (view from entrance).

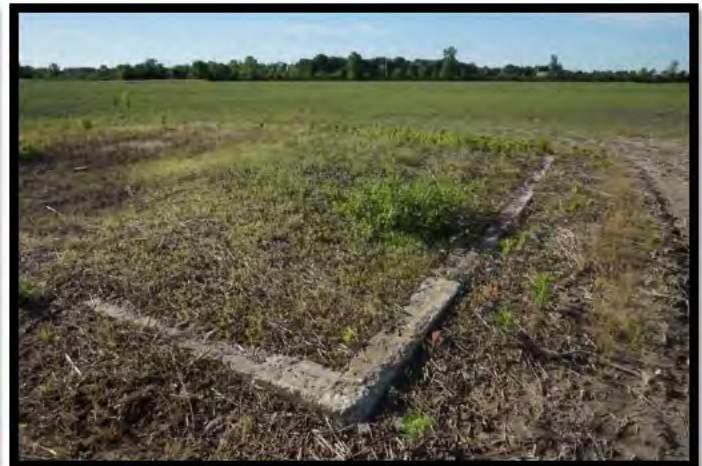
Photograph 4: Sand Road property, concrete foundation.

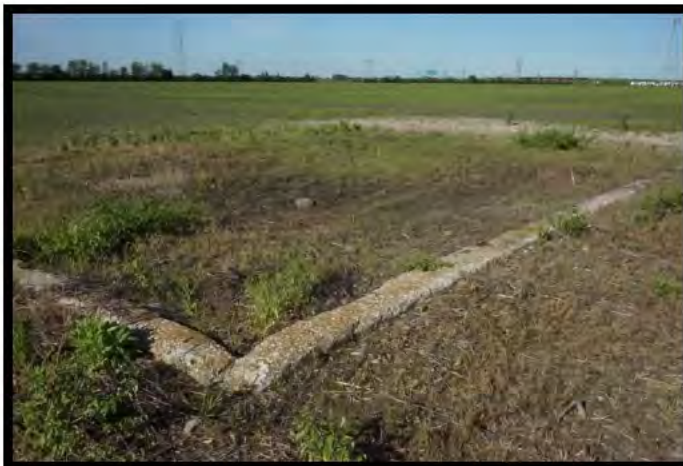
Photograph 5: Sand Road property, concrete foundation.

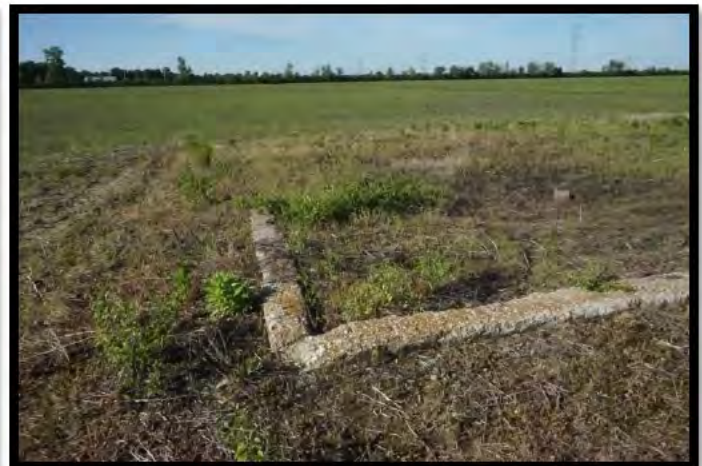
Photograph 6: Sand Road property, concrete foundation.

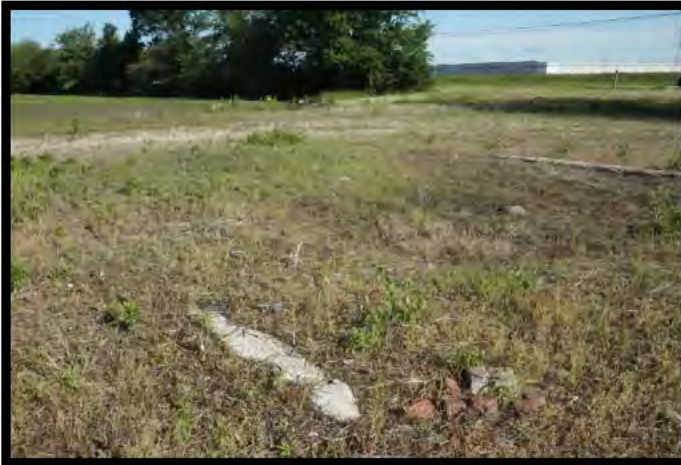
Photograph 7: Sand Road property, concrete foundation.

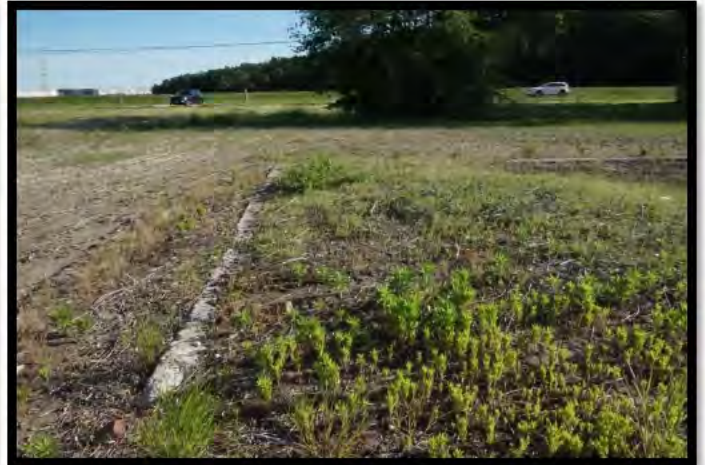
Photograph 8: Sand Road property, concrete foundation.

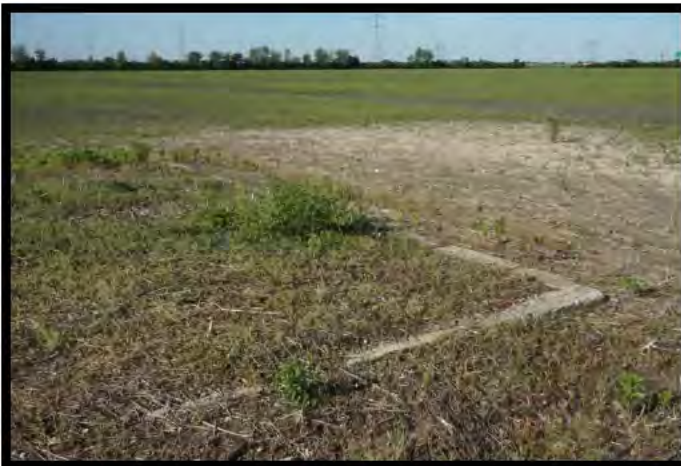
Photograph 9: Sand Road property, concrete foundation.

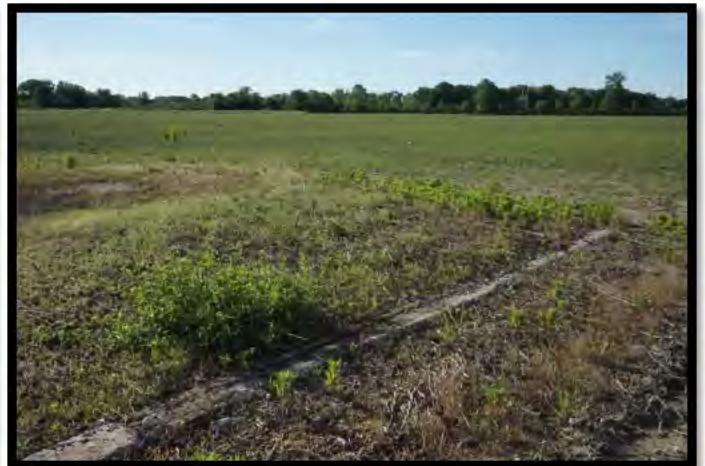
Photograph 10: Sand Road property, concrete foundation.

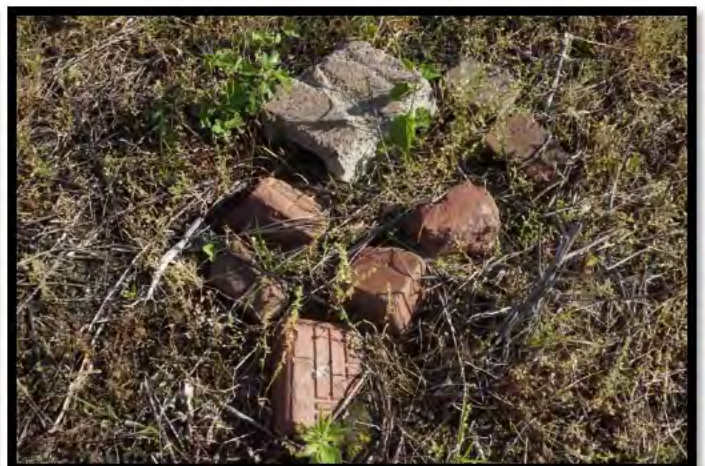
Photograph 13: Sand Road property, concrete foundation.

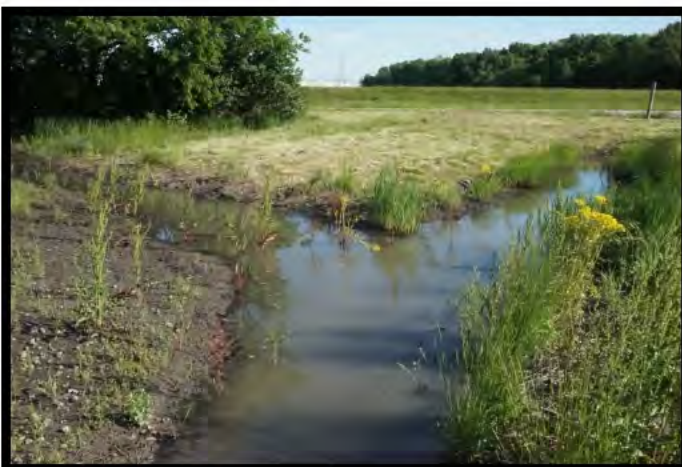
Photograph 15: Sand Road property, drainage swale.
